E&M Engineers and Surveyors, PC

Fall 2009

Skinner Hollow Road Bridge Replaced

Seismic Retrofitting Highway Bridges

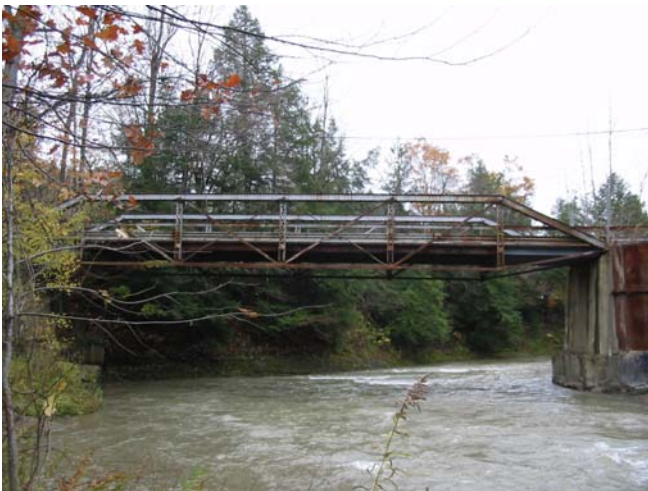
Figure 1: Former Pony Truss Bridge

The bridge was originally built at another location in 1895, was moved to Skinner Hollow in 1949 and was rehabilitated in 1990 (See Figure 1).

The approaches to the existing bridge were gravel with a very sharp horizontal curve (approx. 150 ft. radius) on the east approach and a 350 ft. radius curve on the west approach. The maximum grade for the east approach roadway was approximately 10.8% and the maximum grade for the west approach was approximately 5%. The combination of the sharp horizontal curves and the steep grade made accessing the bridge dangerous, especially during inclement weather. The bridge was posted for a maximum load of 16 tons prior to its replacement.

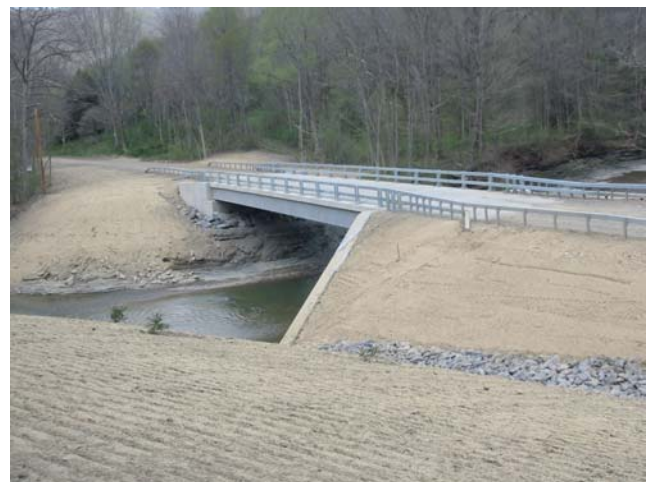
Figure 2: New Prestressed Box Beam Bridge

The new bridge is an approximate 107 ft. single-span prestressed adjacent box beam bridge with a concrete deck on reinforced concrete abutments and wingwalls (See Figure 2).

The foundations for the new abutments and wingwalls are reinforced concrete spread footings that were installed on and connected to bedrock, which is located close to the ground surface. The foundations for the wingwalls were stepped in order to reduce the excavation, concrete, backfill material and ultimately the cost required to construct the new bridge.

The clear distance between the steel bridge railings on the new structure is approximately 19 ft. and there are concrete approach slabs on each end of the bridge.

The new bridge was built upstream of the existing structure in order to improve the horizontal alignment of the approach roadway to the bridge. 500 ft. radius curves are now used to access the bridge from each end and the maximum grade of the east approach is 10%.

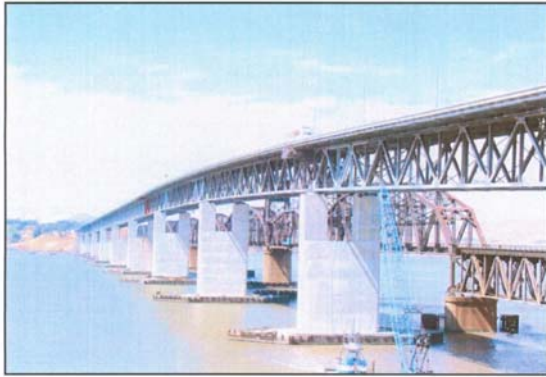
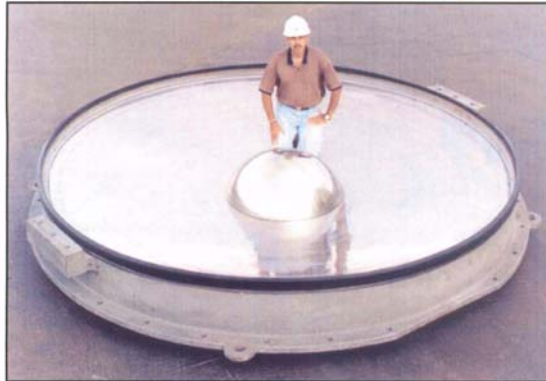
The picture below shows a large friction pendulum seismic isolation bearing used on a bridge in the San Francisco Bay area.

Also used are new bearings which are more elastic and can absorb energy during an earthquake. There are many proprietary bearings and shock absorbers used in bridges as well as buildings to protect the structure from earthquakes.
