E&M Engineers and Surveyors, PC

Spring 2004

DON'T PUT OFF PAINTING THAT OLD TANK

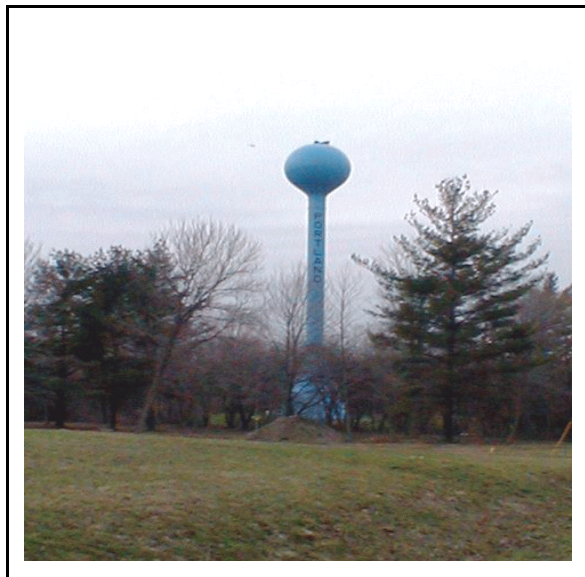
An exterior epoxy coating systems was applied to the Portland tank (shown in photo). Surface treatment included degreasing and pressure washing with a biodegradable detergent and SSPC-SP11 power tool cleaning to bare metal where required. The exterior system included an epoxy coating consisting of a spot primer coat full intermediate coat and a full finish coat.

Since the interior coating systems on both tanks had failed years prior and contained lead based primers it was recommended that the interior surface preparation be SSPC-SP10 near white blast cleaning. Necessary repair welds and patch plates were installed in all damaged areas.

Interior coating systems on both tanks were chosen from a list of acceptable non-toxic coatings as approved by the New York State Department of Health. A “Hi-Build” epoxy system was applied to the interior of the tanks. This system consisted of a primer coat, a pit filler and surfacer, a stripe coat applied on all welded seams and edges and a finish coat. Upon completion of the interior coating, an impressed current cathodic protection system was installed in the Portland tank.

E&M was onsite to inspect each phase of the project including surface preparation and paint thickness. Coating thickness was tested with a non destructive magnetic thickness gauge. Holiday testing (detection for the presence of pinholes) was performed with a non-destructive holiday detector. Both projects were completed within budget.
